## **Rule 26 Report**

This report is for the residents at 16207 E. 47th Place, Tulsa, OK 74134. I have prepared a replacement cost estimate for the roof and exterior of this home. I was also asked to review the existing documentation and other written reports that addressed this home and provide my opinions on them.

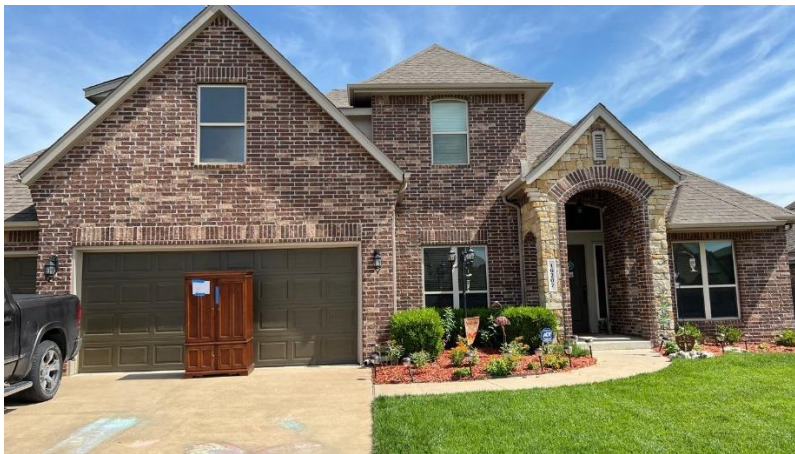
The Bales Family's home is a single-family home in Subdivision Trinity Creek II addition. The home was built in approximately 2010. The home has a laminated composition shingle roof which was approximately 12 years old at the time of the Bales Family's claim with State Farm Insurance. Based on a conversation I had with the Bales Family, it is my understanding they purchased the home in late 2020. Prior to their purchase of the home, they had an inspection performed and no wind or hail damage was noted to any areas of the roof. Below is a photograph of the front of the Bales Family's home:
